Ultimate Storm Anchoring

U.S. West Coast cruisers share their experiences after a wayward hurricane teaches them a lesson in how to stay put-or not

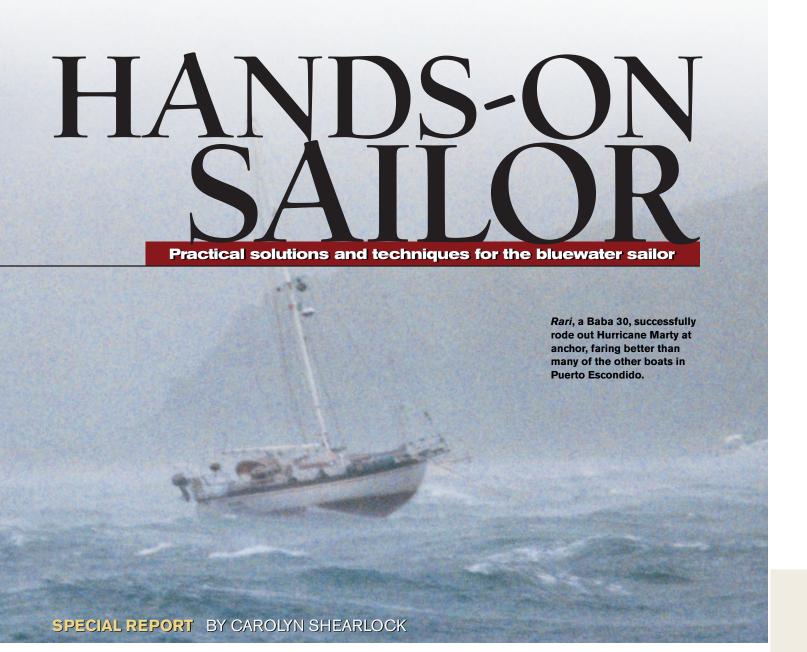
About 80 boats lay to anchors or moorings in Puerto Escondido, the best hurricane hole on the Baja California coast of the Sea of Cortez, when Hurricane Marty paid a visit in September 2003.
